GEOTECHNICAL INVESTIGATION AND SITE CONDITIONS REPORT

KENAI RIVER BLUFF EROSION

KENAI, ALASKA

February, 2007

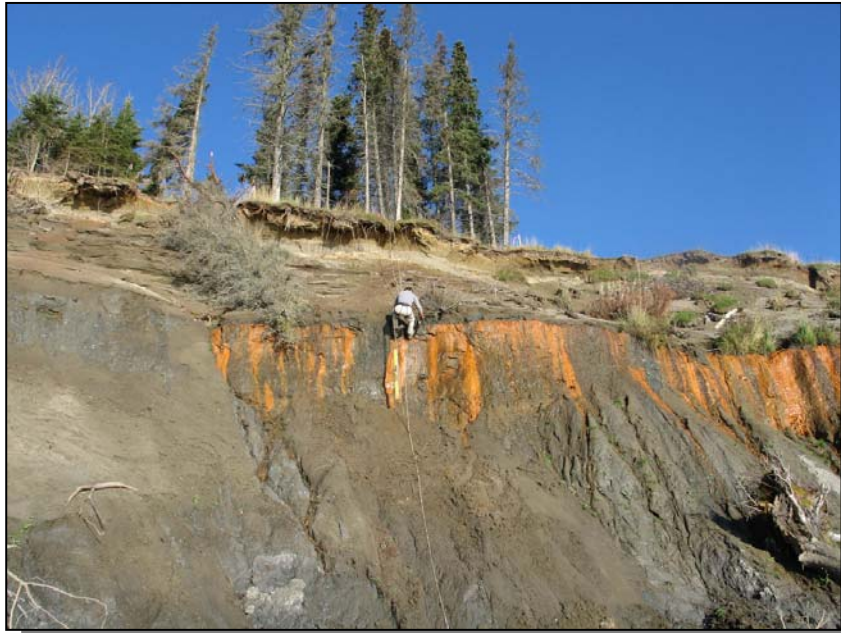
FIGURE 4
BLUFF MAPPING PHOTOGRAPHS

a. Rappelling down the bluff face at Soil Profile SP-D. The four-foot yellow electronic level was used to measure slope angle. Slope distances were measured using the white tape. October, 2006.

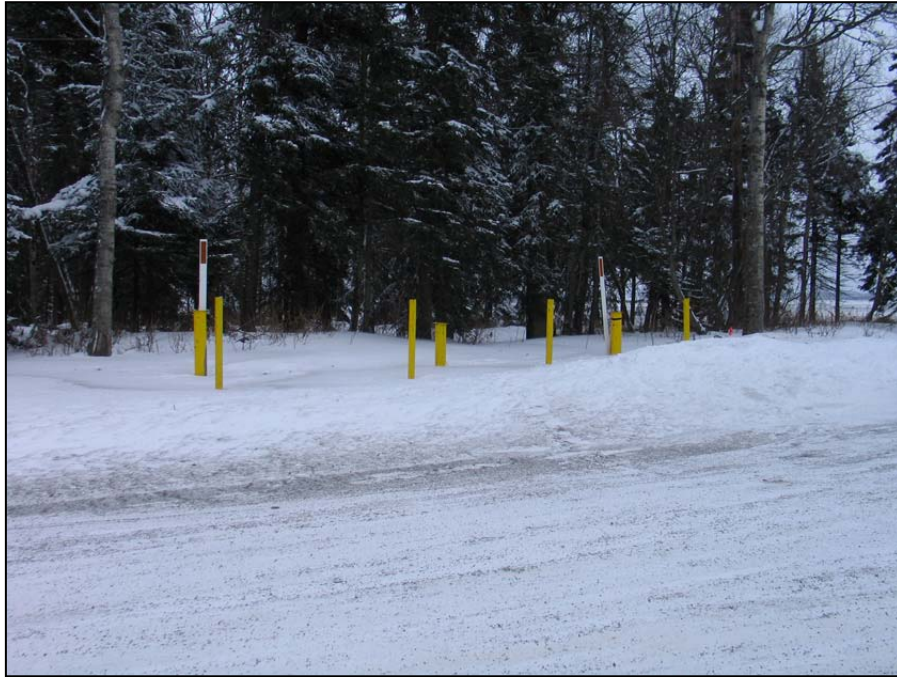
FIGURE 8
PHOTOGRAPHS SHOWING MONITORING WELLS

a. Monitoring well installation at Group 3 borings with protective bollards. December, 2006.

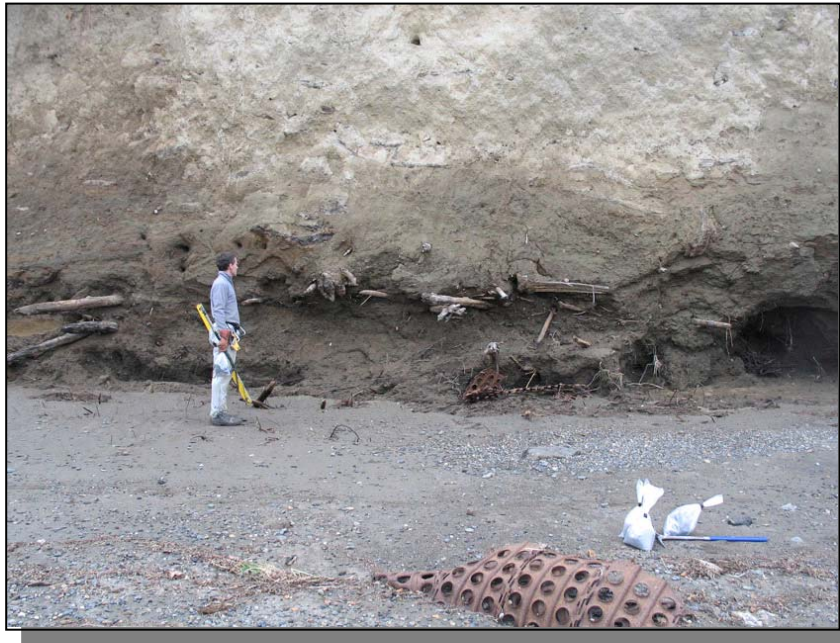
- b. Photograph taken at bottom of slope on left side of photo above.
Note undermining of the slope and "Marston Mat" in foreground. October, 2006.

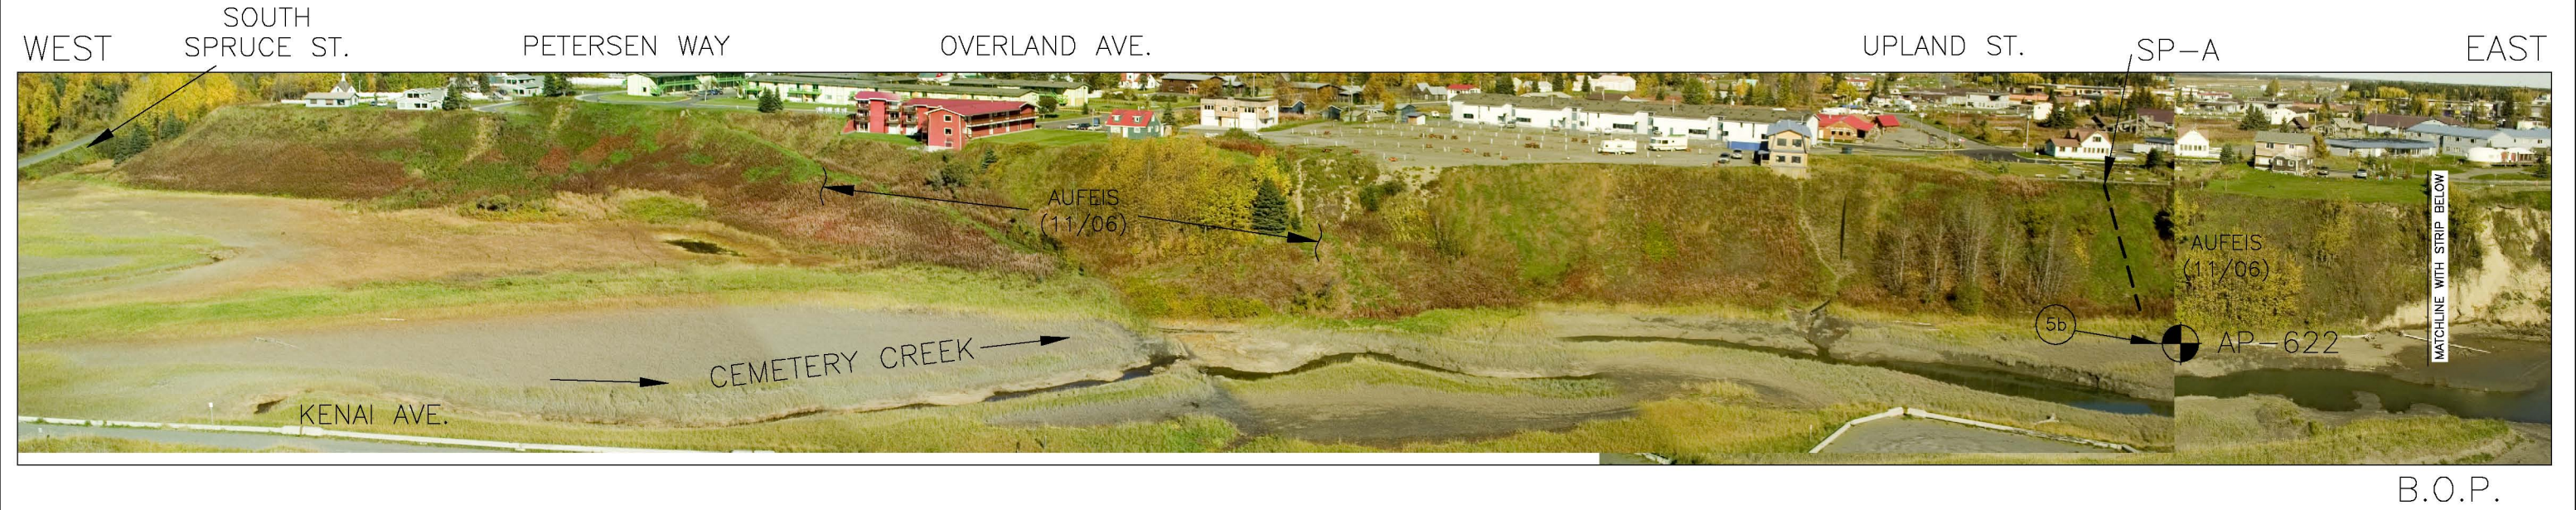
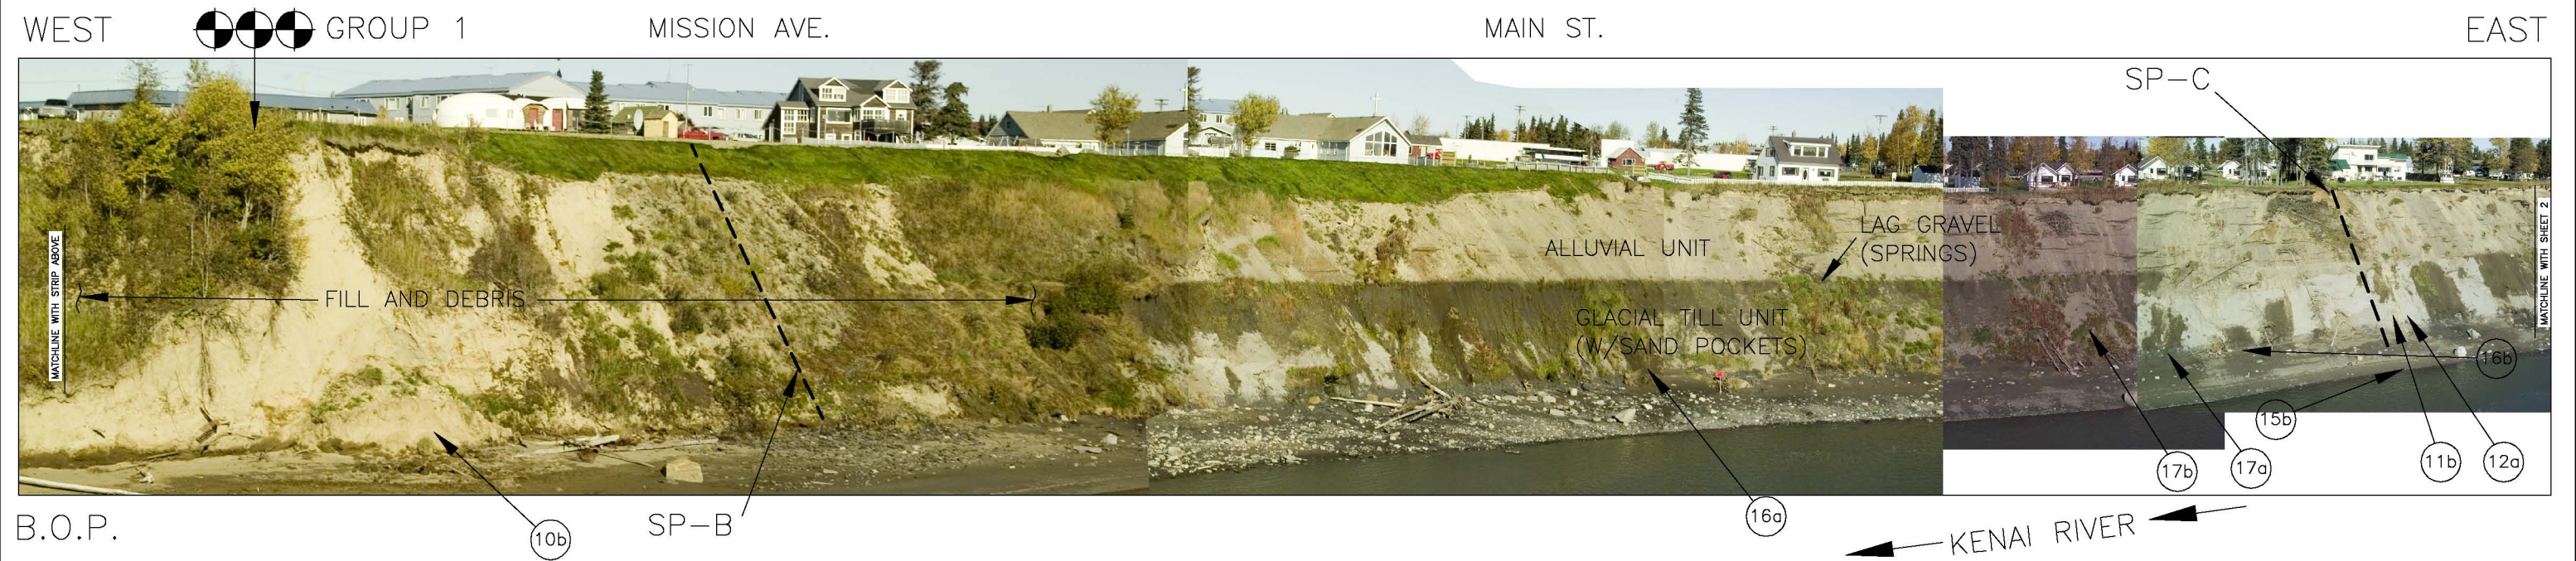
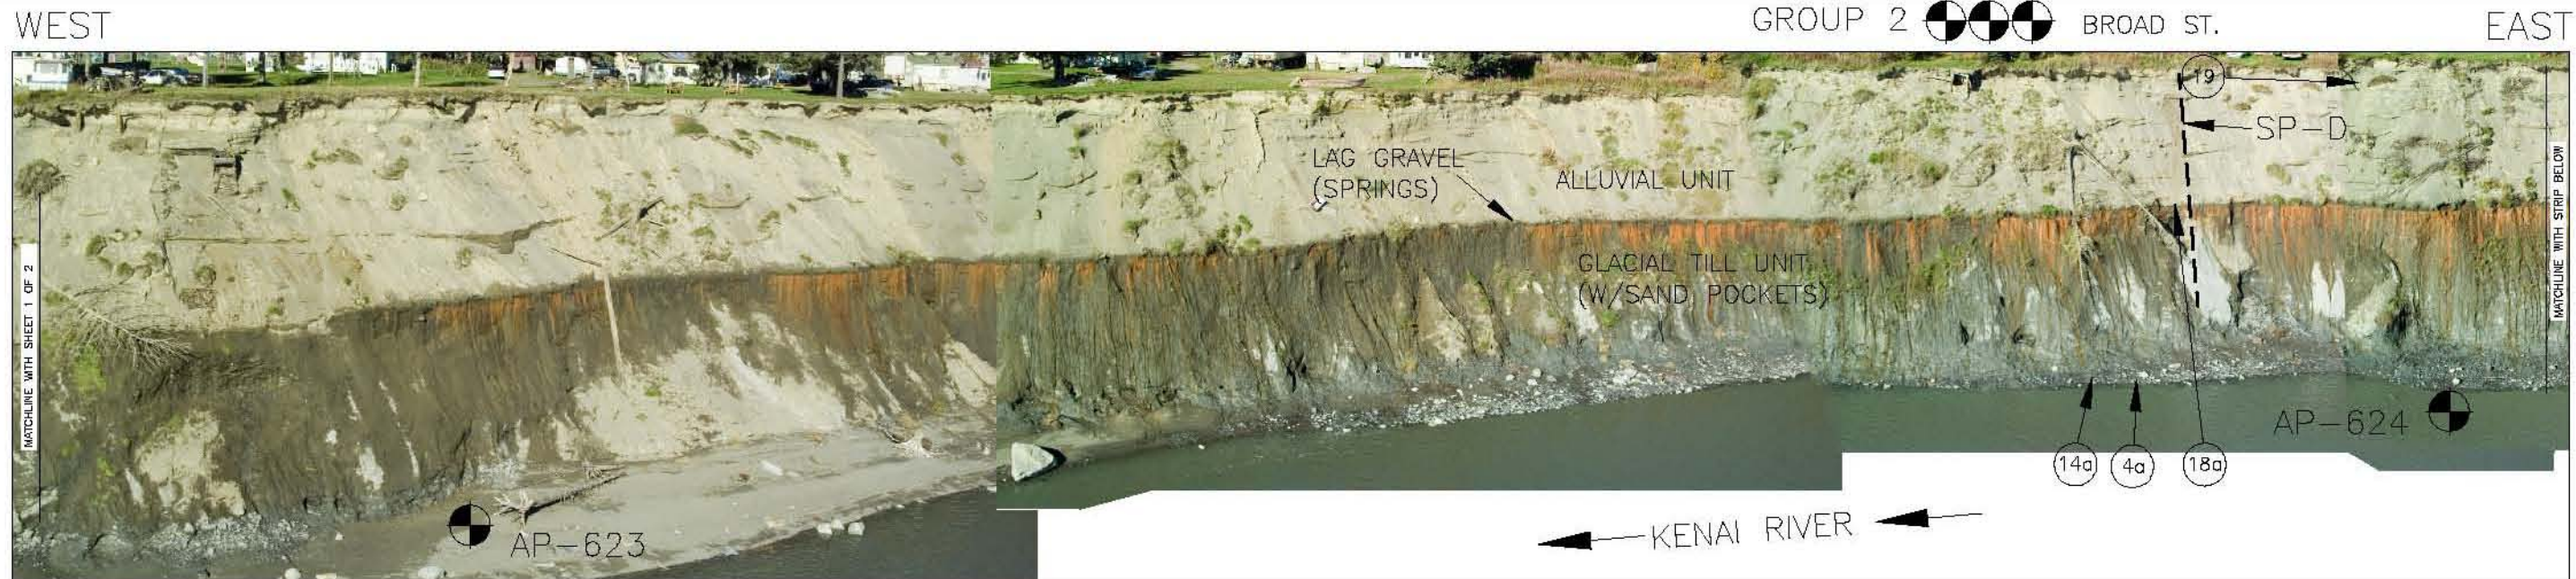
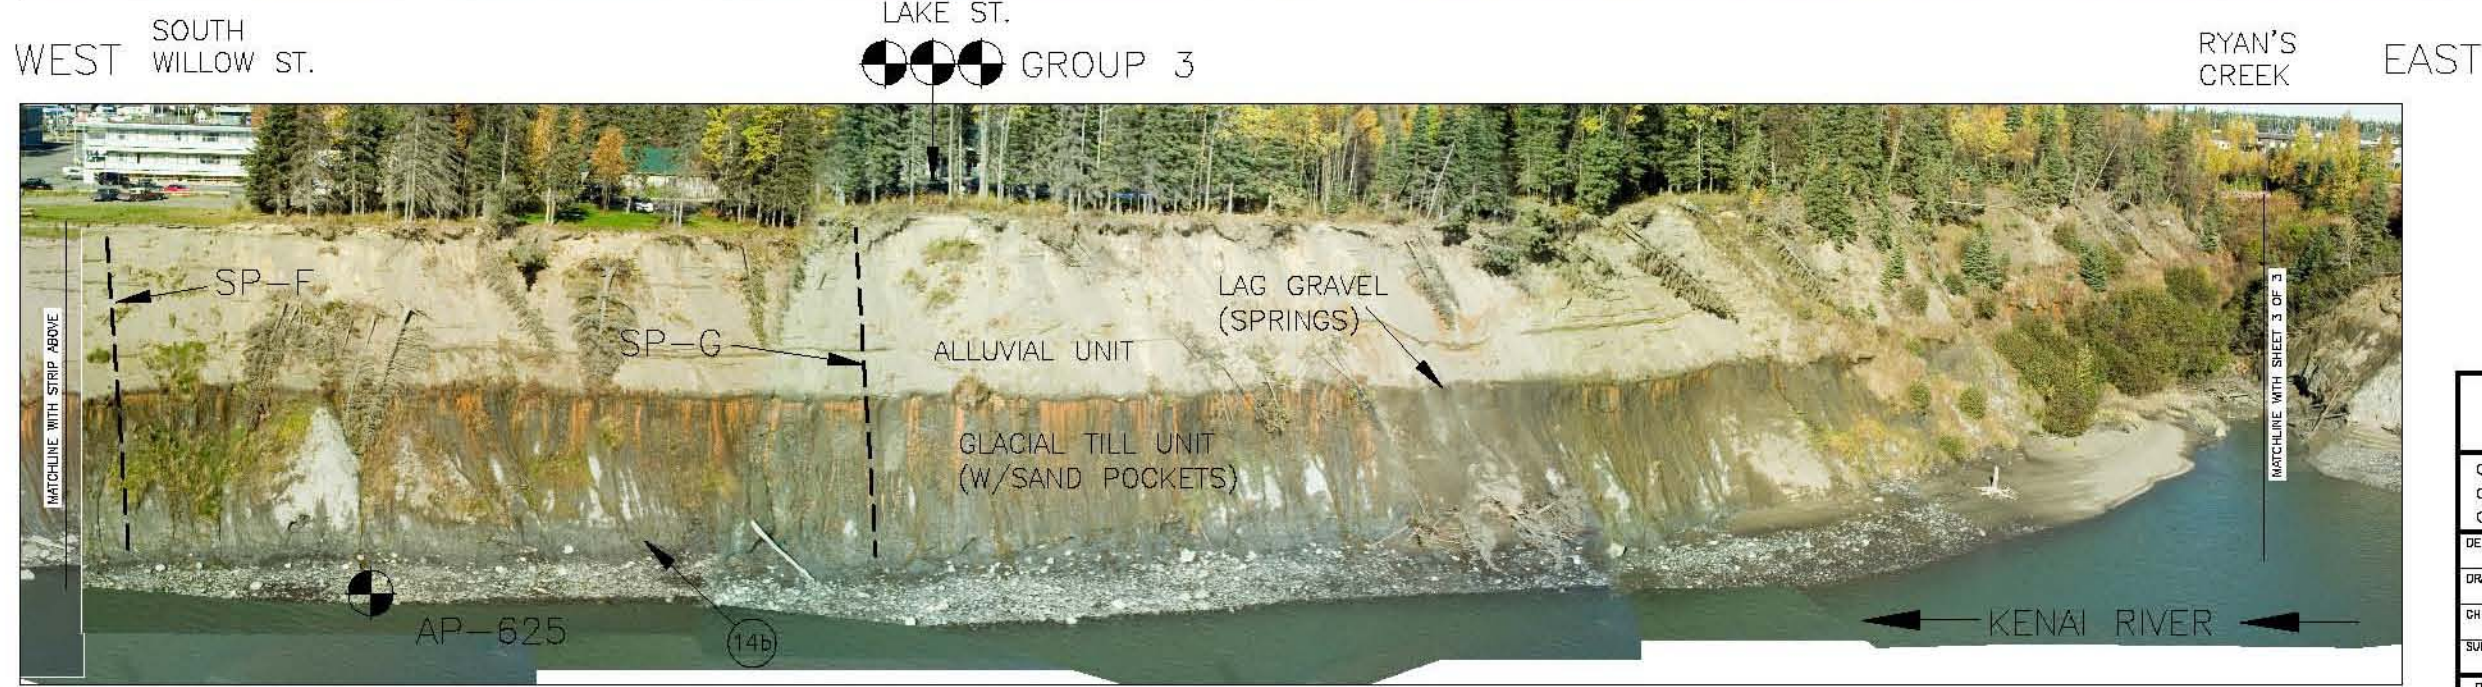
- LEGEND:
- SOIL PROFILES
 - AP-622 TEST BORINGS
 - 16a FIGURES (PHOTOS) IN REPORT

Soil profiles are provided as Drawings D-01 through D-10 of Appendix D. An annotated photo mosaic is presented on Drawings A-08 through A-10. Additionally, a generalized subsurface profile showing interpreted soils and groundwater conditions is presented in Appendix A, Drawing A-11. Soil units reflect those found on the soil logs in Appendix B, but have been generalized and abbreviated for clarity of presentation.
